**National Highway  
Traffic Safety  
Administration**

186-00

Case Vehicle (A): 1998 Plymouth  
Type: Breeze Expresso, 4-door sedan  
Driver: 57-year-old female  
CDC: 12-FZAW-4

Veh. (B): 1994 Peterbilt  
Type: Model 377 6 x 4 tractor with trailer  
Driver: 60-year-old male  
CDC: 99-0000-0

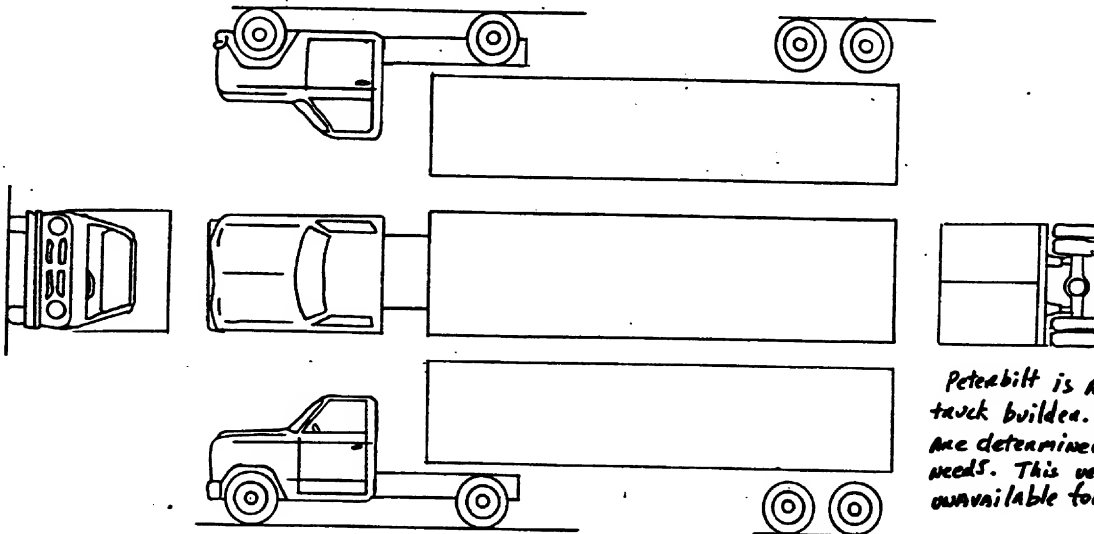
VEHICLE DAMAGE

*Peterbilt is a custom  
truck builder. Specifications  
are determined by customer  
needs. This vehicle was  
unavailable for inspection.*
